KOP 7
South of Cortez

Figure 3.9-8

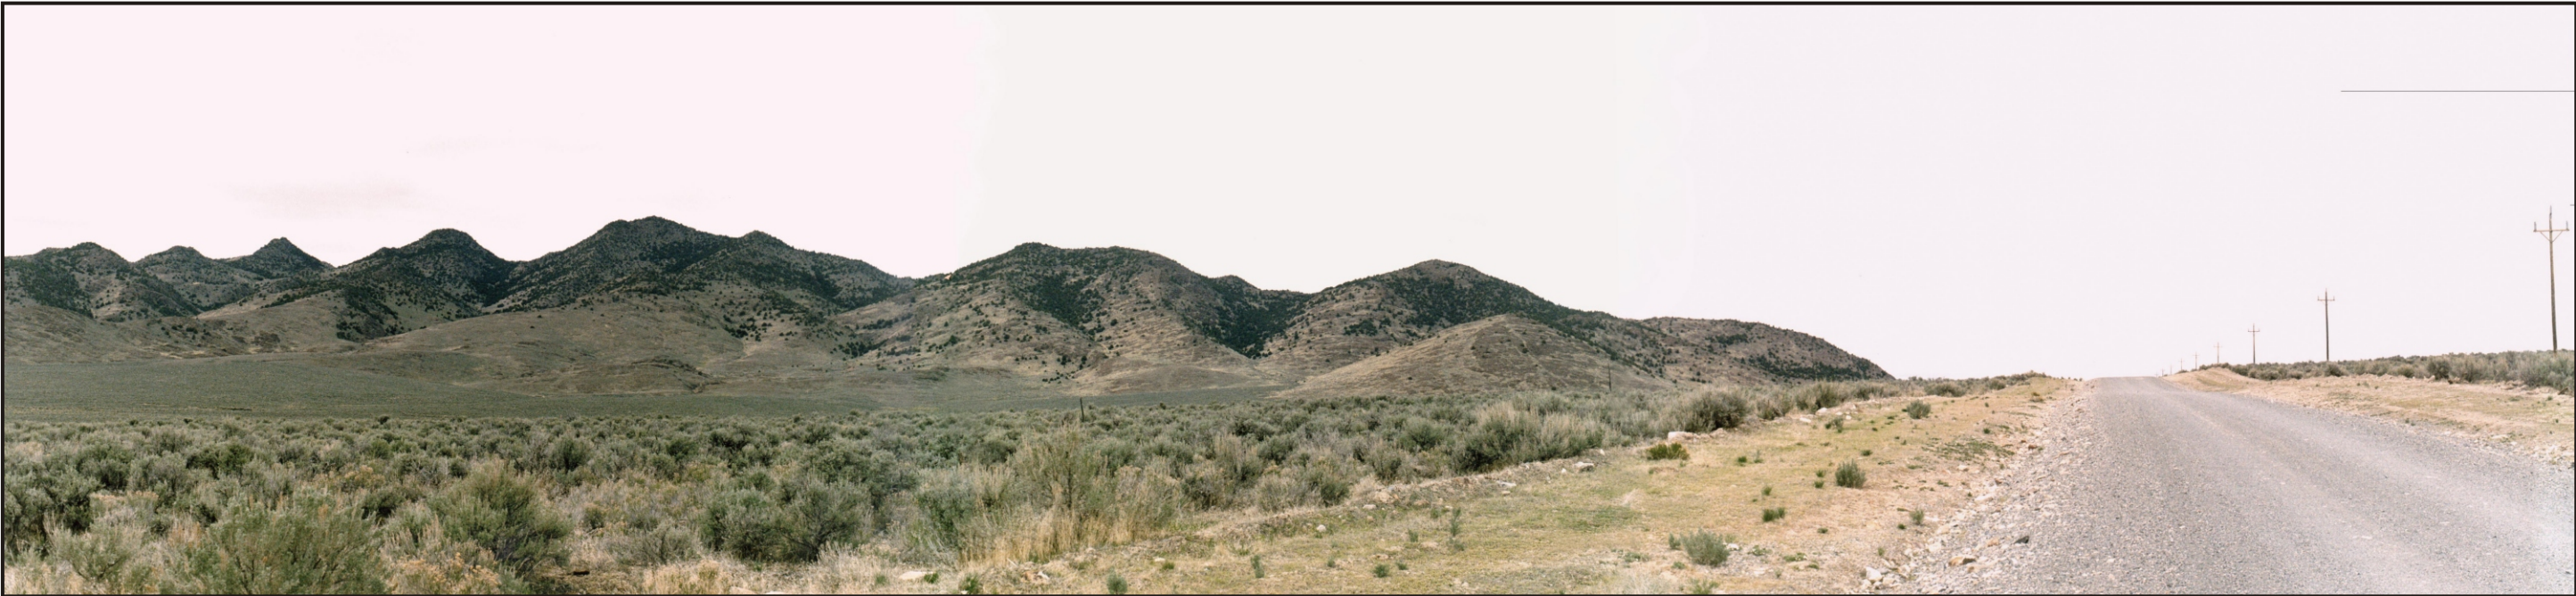
Context Photograph
Note: Proposed transmission line will be visible crossing over mountain ridgeline in the middleground view.

Type/Sensitivity of Users: Local highway travelers with a moderate interest in visual quality
Volume of Users: A moderate to low number
T/L Distance from Viewer: Middleground and foreground views
T/L Prominence in Landscape: From low to high - closely backdropped by nearby landforms and skylined
Existing Modifications: Wood pole distribution line and minor past mining disturbance

Contrast Rating: Moderate
VRM Class: III
Visual Impact Rating: Medium
